# Airport-In-The-Sky

*Rebuilding a Piece of History*

*By Rob Davis, Ph.D. & Gordon Rayner*

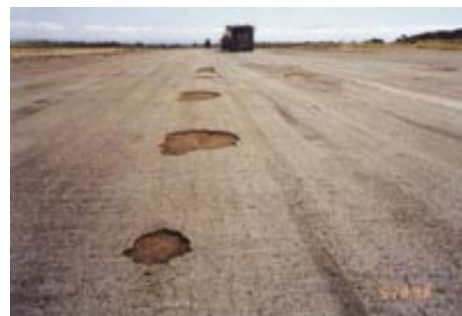
The Airport runway, apron and taxiways

surfaces were found to be in varying states of service. The original pavement appeared to be built up layers of oil and screenings (Chip Seal). Over the years the surface had been further treated with a variety of Chip Seal, Slurry Seal and seal coat preparations. The last of these appeared to be about 10 years old with only cold mix patching being done since that time. Time and weather has taken its

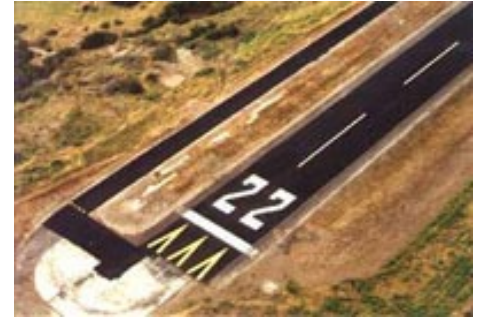
The runway, taxiways and apron were

severely cracked and potholes were abundant along the entire surface. Many of the cracks penetrated through the entire surface to the base and there was extensive shrink cracking throughout the seal coat that had been applied on the apron areas. Proposals and recommendations were made based on the condition of the surface at that time and included options for various alternative treatments. This was before the 1998 El Nino storm system hit with a vengeance. Storm damage not only delayed the start of the project by months, but also did considerable damage to the existing surface. Repair options were re-evaluated several times during this phase to accommodate these changes as well as the new problem of having a water-saturated base. Repairs needed to begin as soon as weather conditions would allow. To make the best use of the available dollars, CPM had to design a system that could be built without the expensive process of hauling an asphalt plant to the island. This meant designing and using asphalt based, cold applied surfacing materials.

- Cleaning, preparing and treating the distressed and failed areas with one or more treatments of Chip Seal.
- Placing a polymer-modified Chip Seal on the entire surface once repairs are completed.
- Performing a rut filling, depression leveling and re-profiling operation using a highly modified material produced by RPM equipped RoadSaver Microsurfacing machines.
- Resurface the entire surface with a modified RPM 2 Slurry Surfacing.

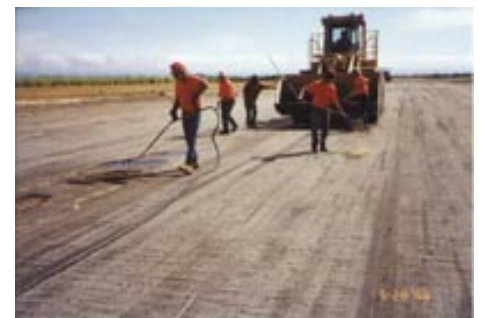
taxiway potholes were patched by crack filling with emulsion and then applying with one or more layers of polymer-modified Chip Seal. The process was labor intensive and required that each hole be hand-sprayed with LMCRS (Latex-Modified Cationic Rapid-Set) emulsion and then treated with chip aggregate. All repairs were rolled with a pneumatic roller. Some areas, such as the edge of the taxiway, were repaired in the conventional manner by spreading the emulsion with the boot trucks and applying the chip aggregate with the chip spreader. In other words, these areas, as well as all the repairs and other weak areas, would ultimately receive a double Chip Seal. Upon completion of the patching and

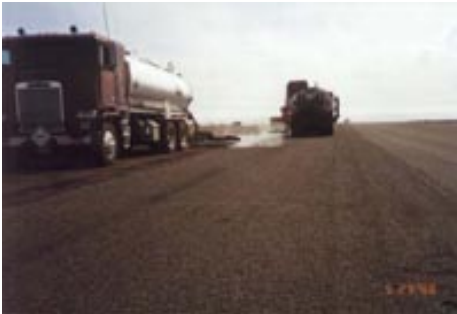
repair work, the final surface coat of Chip Seal was applied to approximately 420,000 square feet. The final chip seal application began with the placement of Latex-Modified Cationic Rapid-Set asphalt emulsion (LMCRS-2h.) A pair of Bearcat distributor trucks spread the emulsion at the rate of .28 gallon per square yard. This was immediately followed by the application of 18-20 pounds per square yard of medium-fine (5/16) chips, which were set in place by pneumatic tired rollers. The final surface application began at 7:30am on May 29th and was completed at 7:00pm the same evening. Any excess screenings were swept the following day. The Chip Seal equipment, less one broom and a pneumatic roller, was then trans-

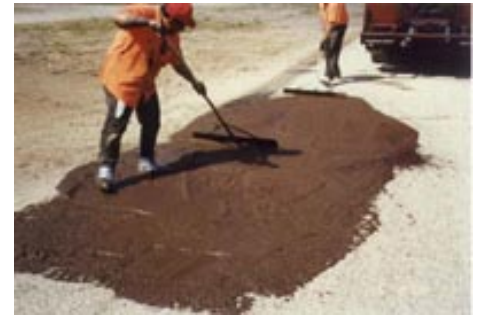
and methods developed by CPM. The patching materials used a combination of LMCQS-1h (Latex-Modified Cationic Quick-Setting) emulsion with 3% Synthetic

Butadiene Rubber co-milled into the asphalt emulsion. In addition, 4% Ethylene Vinyl Acetate was post-injected into the mix through the RoadSaver RPM system. For further strength, a blend of fibers and cement was added to the mix. For deep holes, the aggregate was modified with a larger stone matrix.

This mixture was initially applied to the potholes and uneven surface areas to correct surface irregularities, which were unable to be fully corrected by the chip seal operation. Most of the holes and uneven surface were worked by hand for the first lift and then profiled with a specially constructed spreader box and additional material. Approximately 100,000 square feet of profiling and leveling was completed on June 2nd and 3rd. Some areas required multiple applications of this mixture, and additional fiber and larger aggregate was added to lend strength to the deeper areas. A pneumatic roller was used to compact all patched areas.

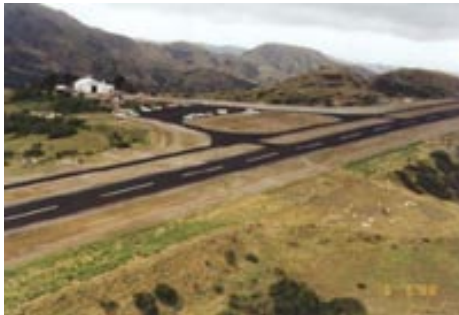
RPM Surfacing Systems have been under development by California Pavement Maintenance Company since the late 1980's. Using internal testing and development facilities and their own equipment design and fabrication unit, Rayner Equipment Systems, CPM has achieved significant improvements in the search for better Preventative Maintenance Systems.

RPM Surfacing offers flexibility in design to better service the wide variations in pavement needs such as those required for the Catalina Island Airport. Special polymer binders are used to increase the strength of the RPM Surfacing mix and help raise the softening point of the base asphalt blend. Added materials, such as carbon black, assure a dark color and provide protection against oxidation and ultraviolet light. The dark color provides a better background for pavement markings and provides a uniform color over the entire resurfaced area. This is especially useful on airport runways where the color differential helps the visibility in areas of overcast or smog. After opening of the airport, one pilot commented, "I thought I was on the wrong island!"
